Manhole Inspection Summary

Manhole # S27C__089MH

Insp Date: **5/13/09 12:02 PM**

Location Address: **718 MURPHY LN**

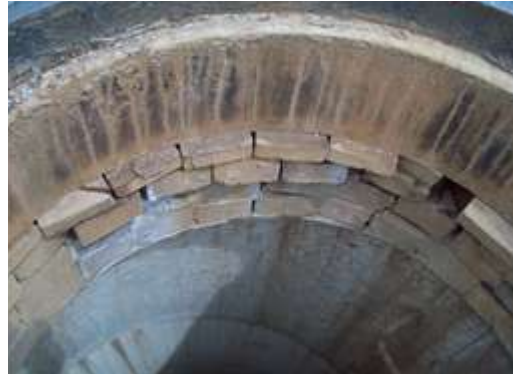
Defect 1

Condition: ☐ Sound ☐ Cracked ☐ Root Intrusion ☒ **Loose Brick** ☐ Deteriorated

LOOSE BRICKS

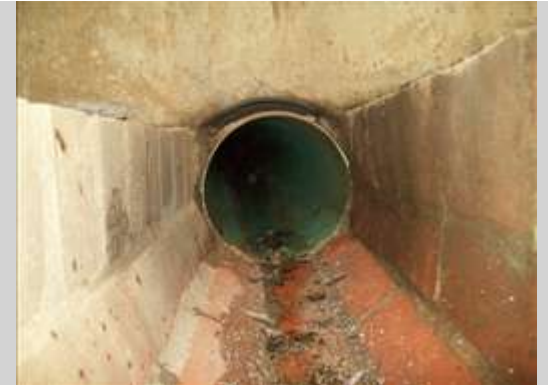
12 O'Clock Outflow

8 in. Circular Gravity Sewer
Pipe Out @ 12 O'Clock

Pipe Material: **PVC** ☐ Pipe Lined

Invert Depth: **11.24** (ft.) Flow Characteristics: **Slow**

Infiltration: **None** Pipe Seal Cond: **Sound**

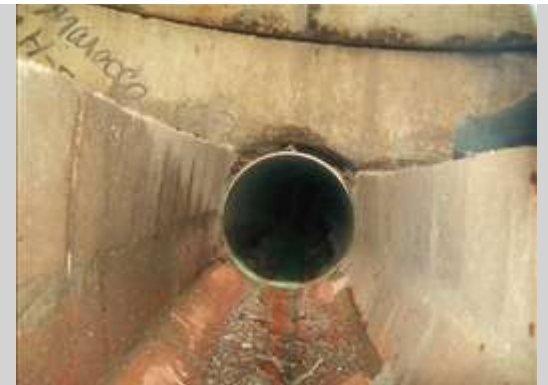
6 O'Clock Inflow

8 in. Circular Gravity Sewer
Pipe In @ 6 O'Clock

Pipe Material: **PVC** ☐ Pipe Lined

Invert Depth: **11.16** (ft.) Flow Characteristics: **Slow**

Infiltration: **None** Pipe Seal Cond: **Sound**
